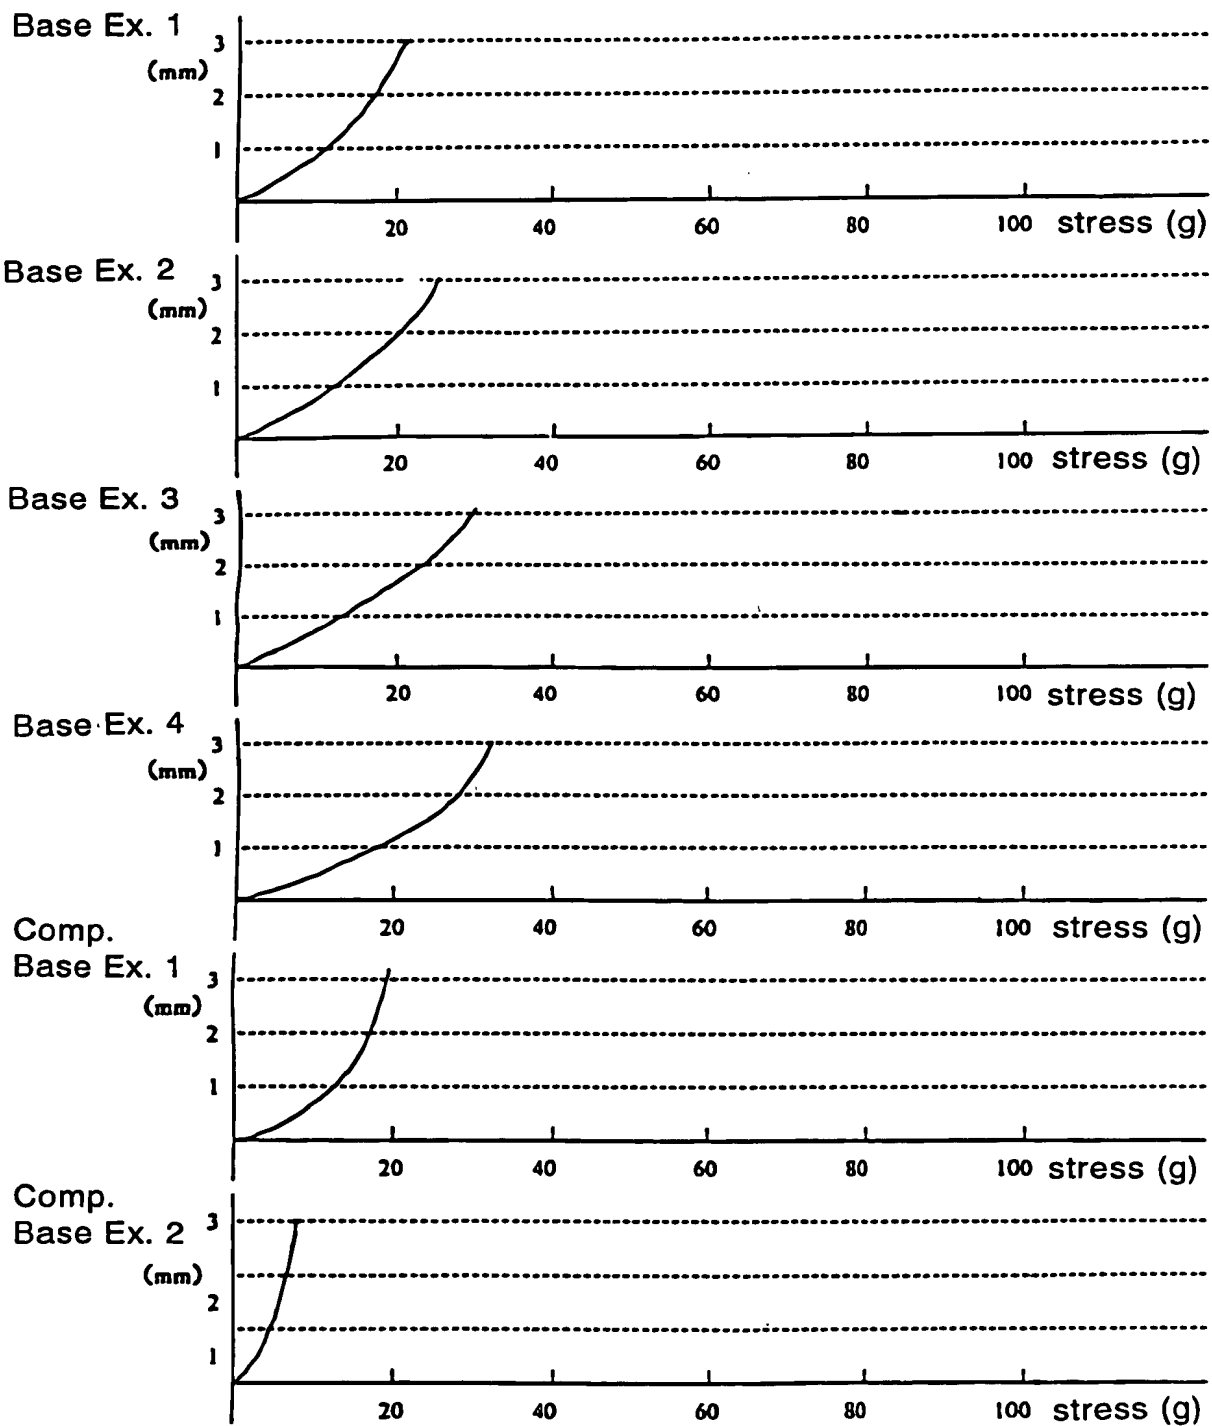
FIG. 1

Needle Penetration Test by Rheometer

Immersion time 0 hrs

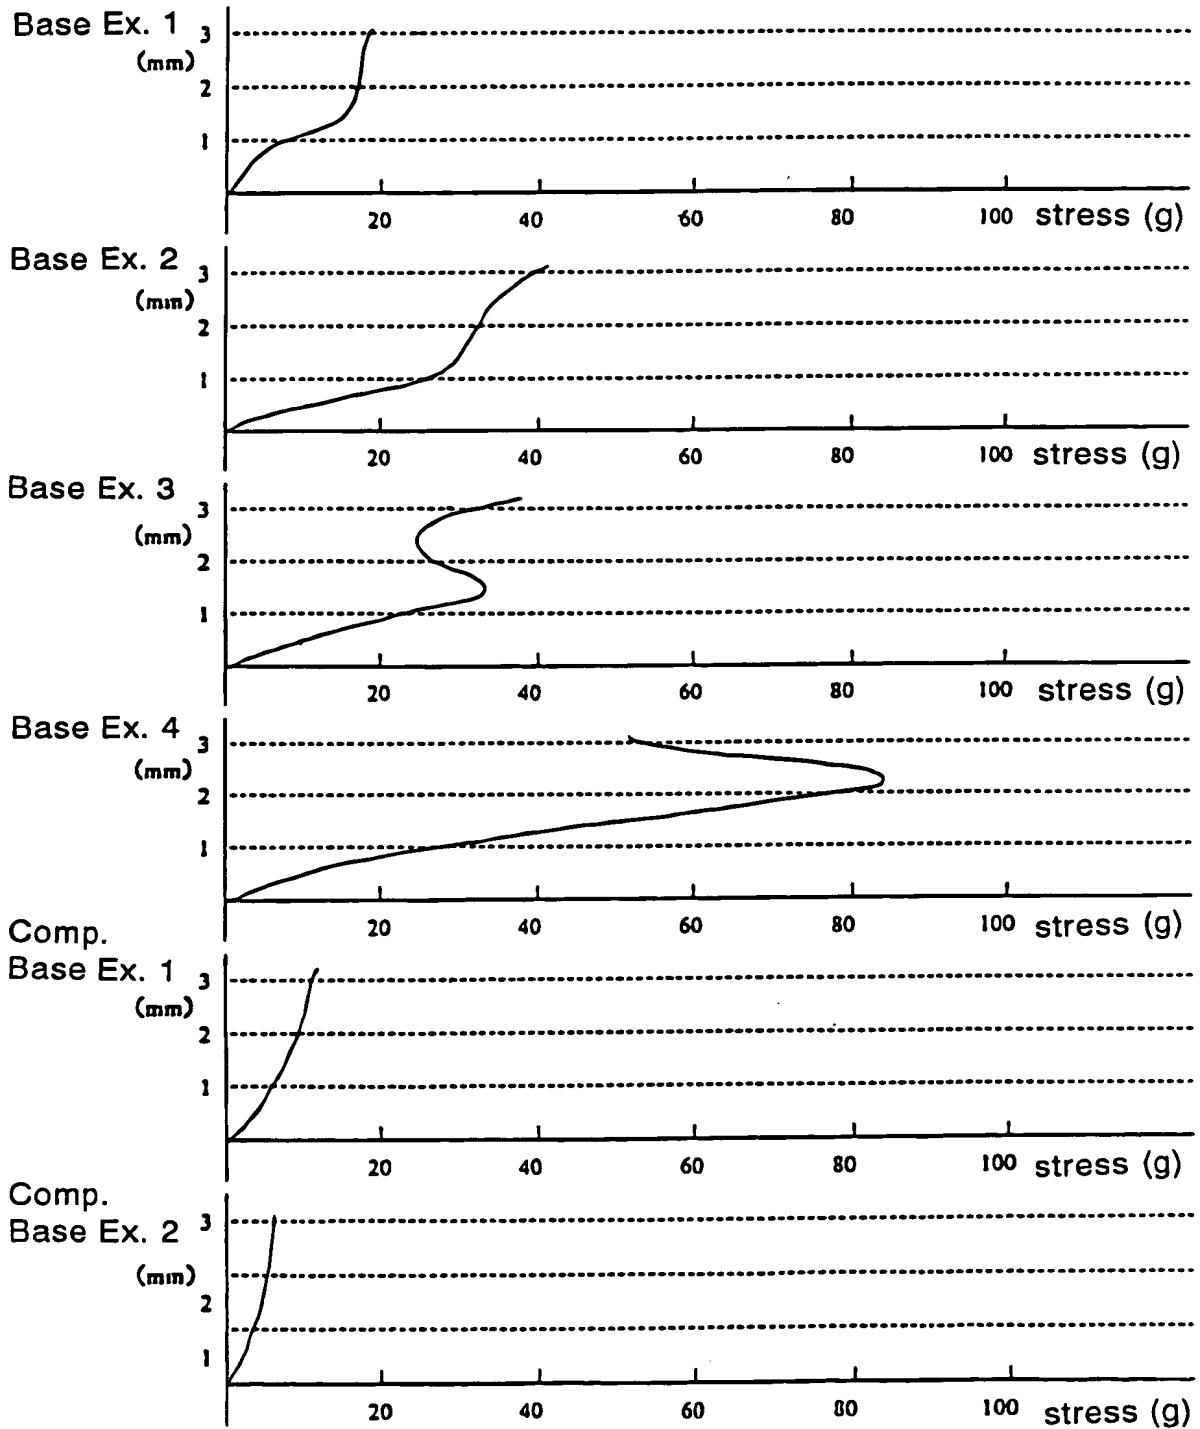
**FIG. 2**

Needle Penetration Test by Rheometer

Immersion time 24 hrs

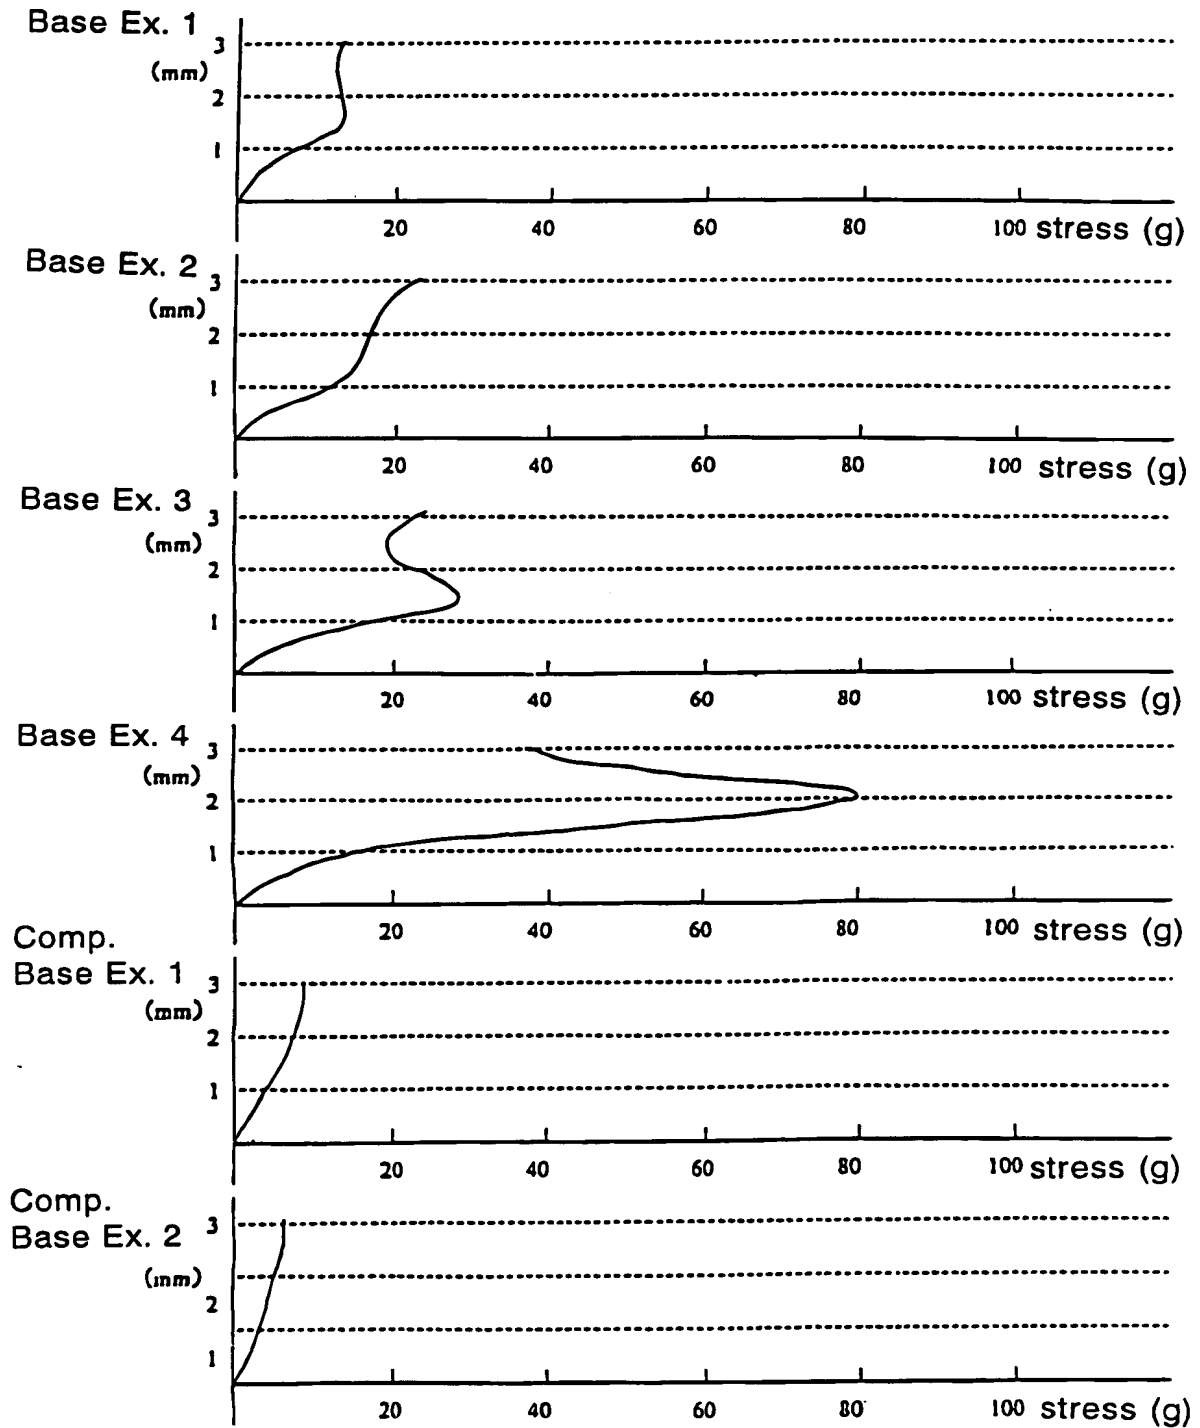
FIG. 3

Needle Penetration Test by Rheometer

Immersion time 48 hrs
